# CT2 COMPRESSOR

May 2009

## PHILADELPHIA GEAR IS DEDICATED TO MAINTAINING MISSION-CRITICAL EQUIPMENT

*Company's Service and Preventive Offerings Help Minimize Downtime*

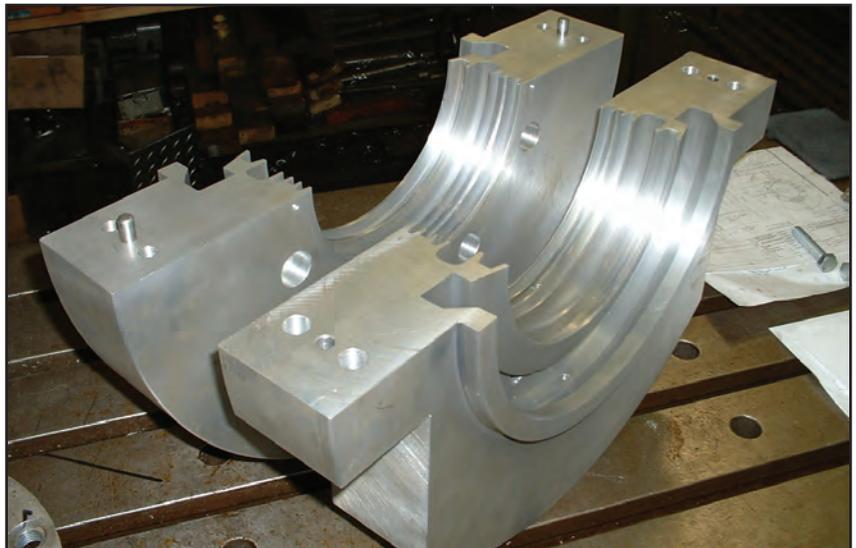
■ Other causes of gearbox failures can be attributed to oil leaks. To prevent this in one application, this "super" seal was developed by Philadelphia Gear engineers to solve leakage problems.

Another of McCloy's experiences involved a constant oil leakage problem with a utility's Frame 5 load box coming from the area of the original 8 in. (203 mm) diameter LS shaft labyrinth seal. The load box reduces the turbine speed from 5100 rpm to 3600 rpm at the generator. Due to the design of the S-424-C5 load box, there is no internal oil deflector baffle plate on the LS shaft to prevent the oil from "roping" down the shaft to the outside during operation. To cure the leak,

Philadelphia Gear's engineering group designed a "super" labyrinth seal measuring 20 in. (508 mm) in diameter and 4.02 in. (102 mm) thick.

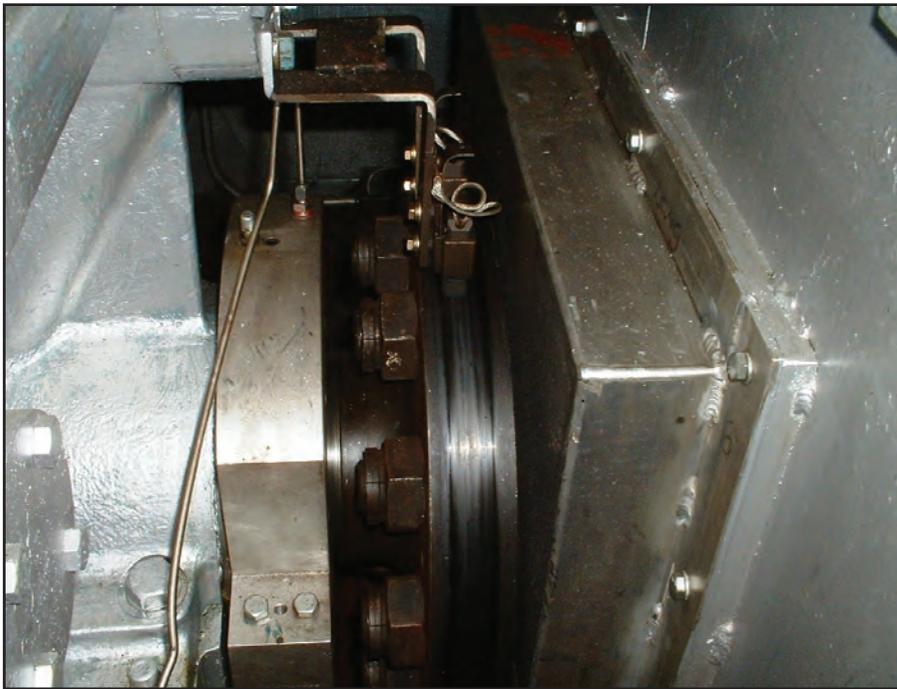
■ The new seal is shown here in service.
